OG-GPS

# CASE 1: MOBILE NETWORK PROVIDER

GNSS interference caused by new signals in telecommunicationS

# CASE 2: RADIO AMATEUR INTERFERENCE

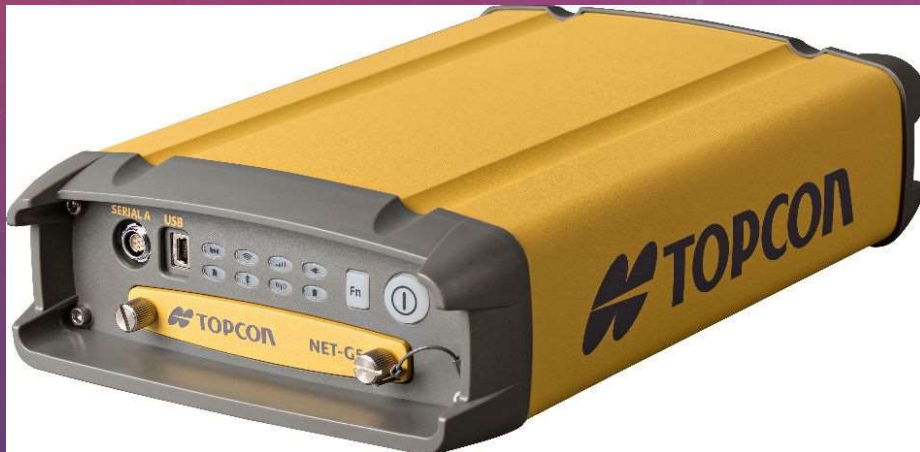
## Topcon NET-G5

Each 06-GPS station has two different receivers on same antenna using an antenna splitter

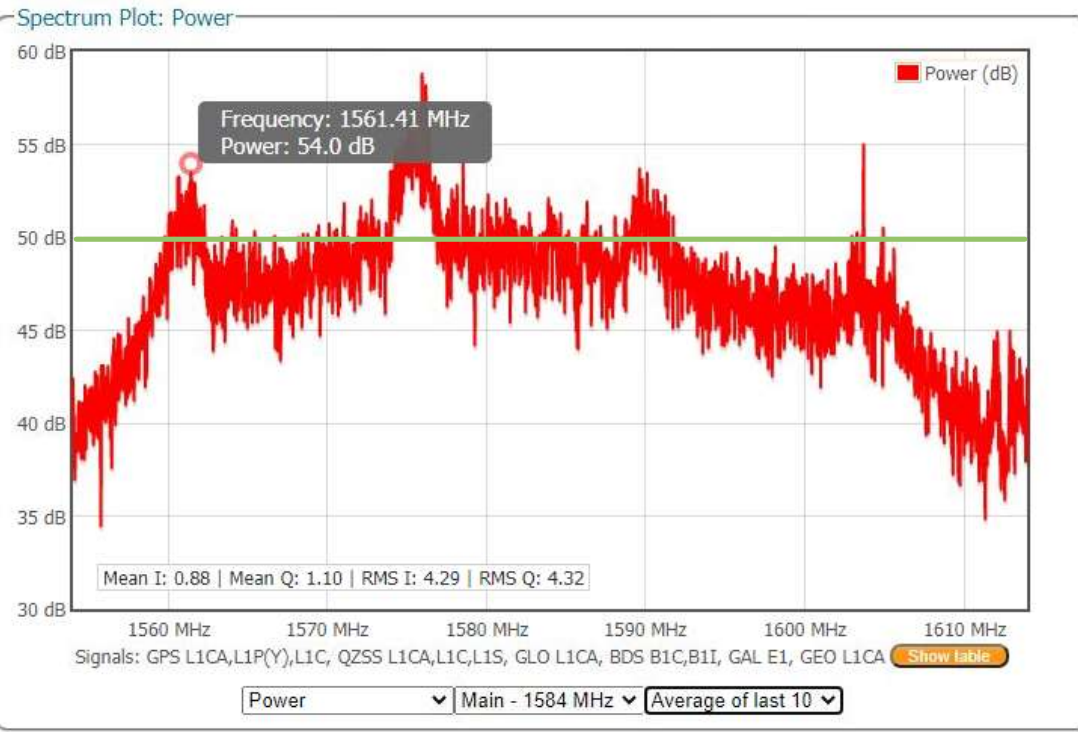
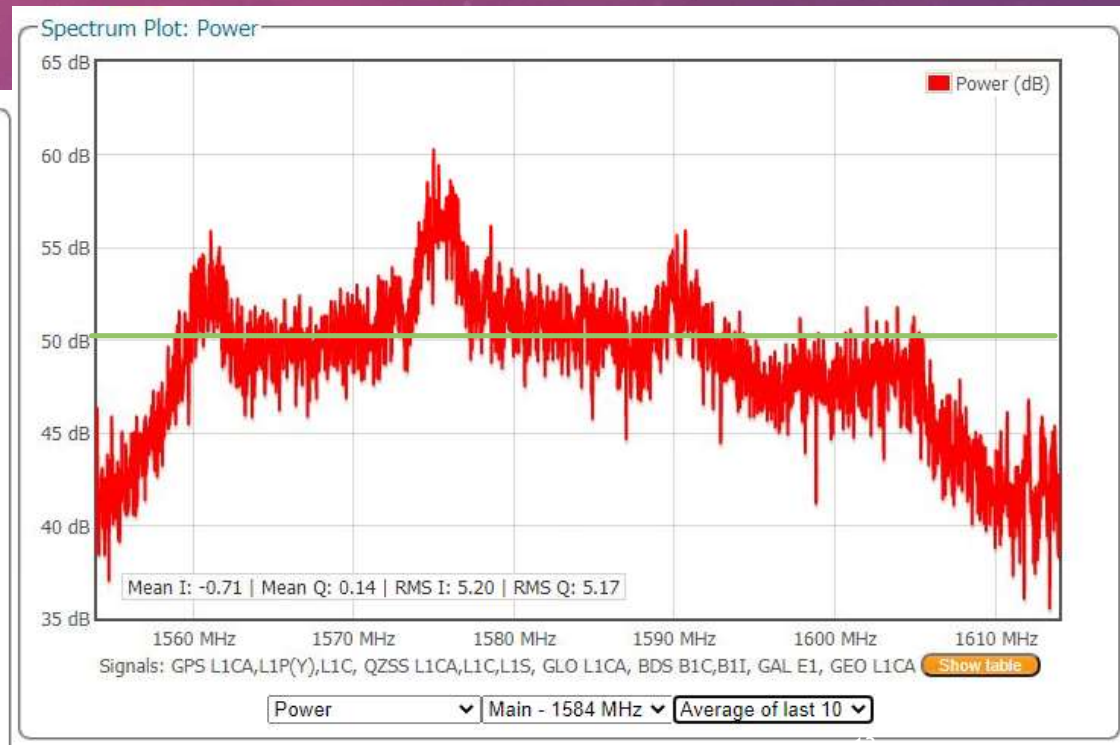
# 1. SPECTRUM ANALYSIS

With interference

Without interference

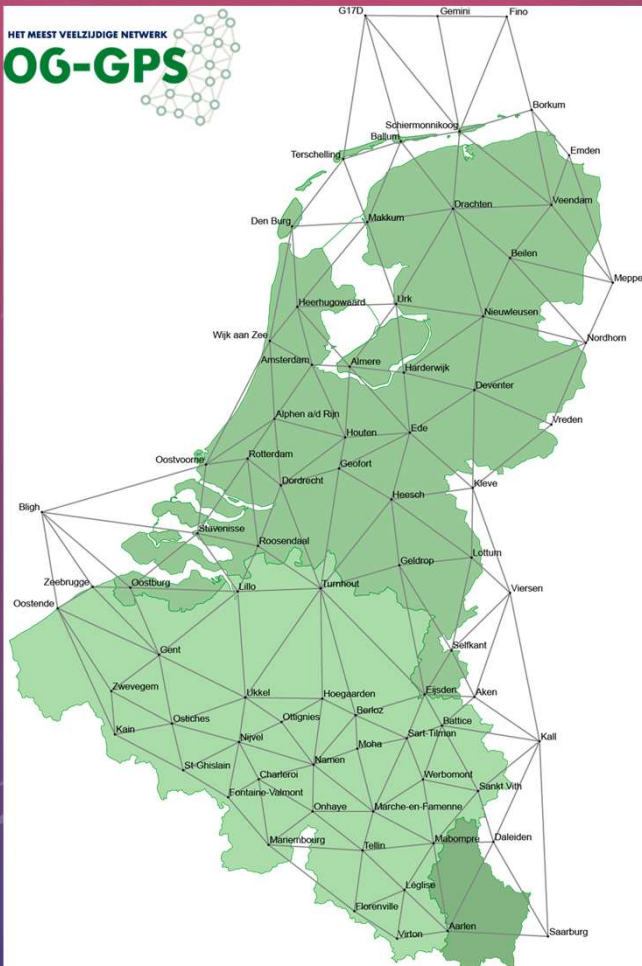
# GEOGRAPHICAL ANALYSES

A manual analysis show that KPN 5G-internet is directly correlated with the interference

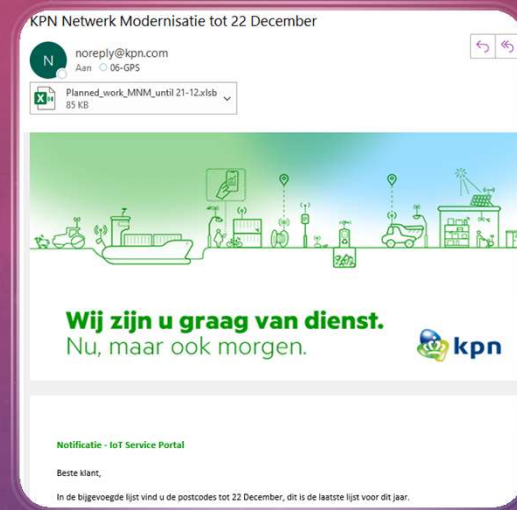
# TEMPORAL FIT WITH THE CASE EDE

Mobile network maintenance and interference had an exact fit

Mobile network antenna pointed to our GNSS antenna.

During maintenance, 5G was also implemented

5G: 784 MHz -> 2<sup>nd</sup> harmonic: 1.568 MHz (close to GPS L1 1.575 MHz)

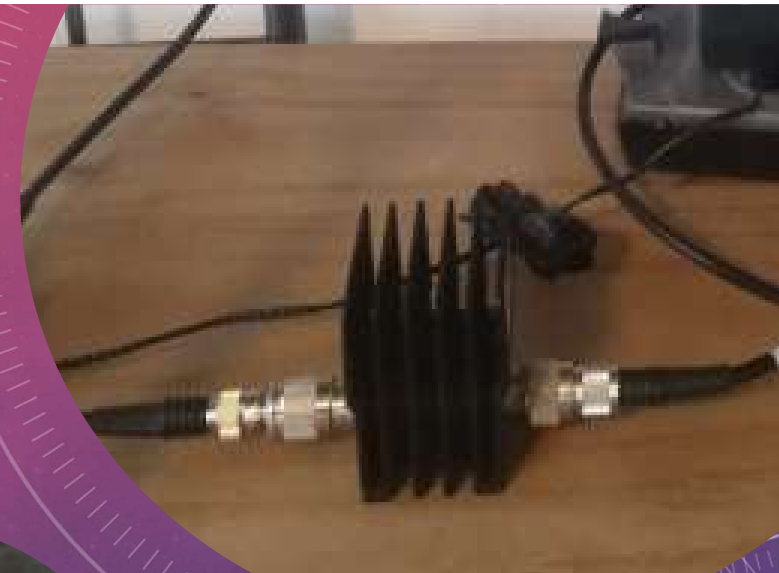
Attenuator -40 dB with cooling

- Two types of attenuator
  - -20dB amplifier DC blocked
  - -40dB amplifier DC blocked
- Proposed new antenna
  - TPSCR.G5C choke ring with Cavity filter

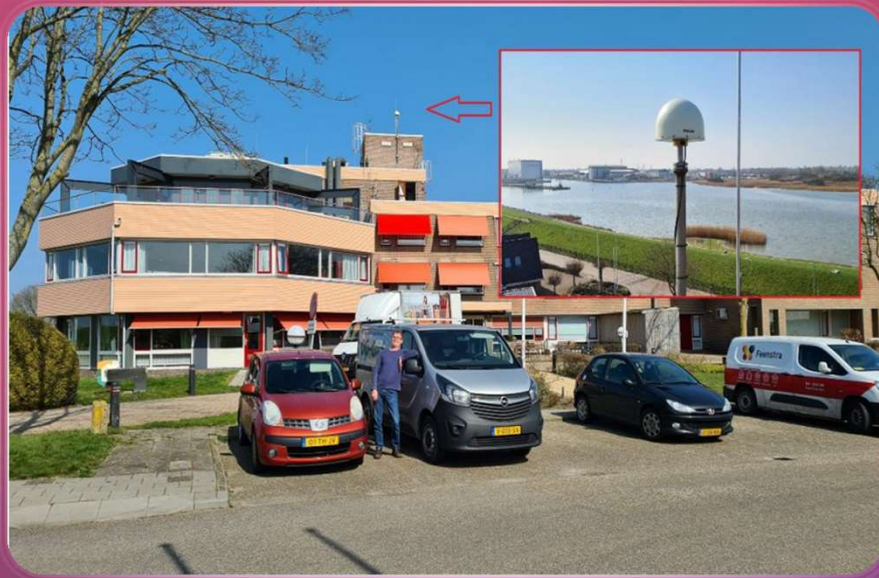
# CAVITY FILTER MITIGATES NEAR BAND INTERFERENCE

- Out of Band Rejection

- <1050 MHz : -80 dB
- 1051 - 1090 MHz : -60 dB ( 39 MHz)
- 1160 - 1300 MHz : - 0 dB (140 MHz) (L2/L3/L5)
- 1370 - 1510 MHz : -60 dB (140 MHz)
- 1540 - 1610 MHz : - 0 dB ( 70 MHz) (L1)
- 1670 - 1699 MHz : -60 dB ( 29 MHz)
- > 1700 MHz : -80 dB

Too broad: Out of band rejection

- <1000 MHz : -60 dB
- 1001 - 1132 MHz : -60 dB (131 MHz)
- 1160 - 1300 MHz : - 0 dB (140 MHz) (L2/L3/L5)
- 1332 - 1418 MHz : -40 dB ( 86 MHz)
- 1515 - 1615 MHz : - 0 dB (100 MHz) (L1)
- 1718 - 1749 MHz : -40 dB ( 31 MHz)
- > 1750 MHz : -60 dB

Small rejection

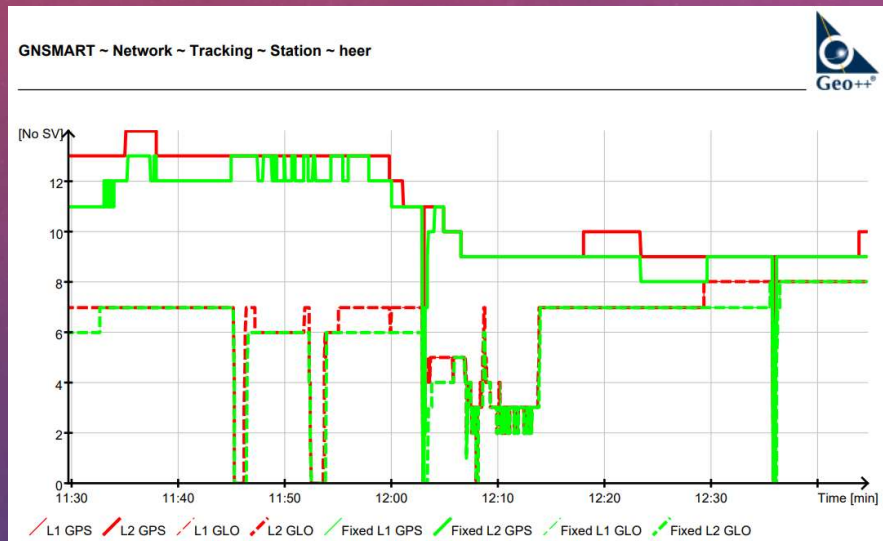
## GNSMART v1 GNNET

- Station Heerhugowaard
- Loss of fix in GNNET/GPPNET (GNSMART Geo++)
- Time depended, no exact schedule
- Only L2 of GPS & GLO affected

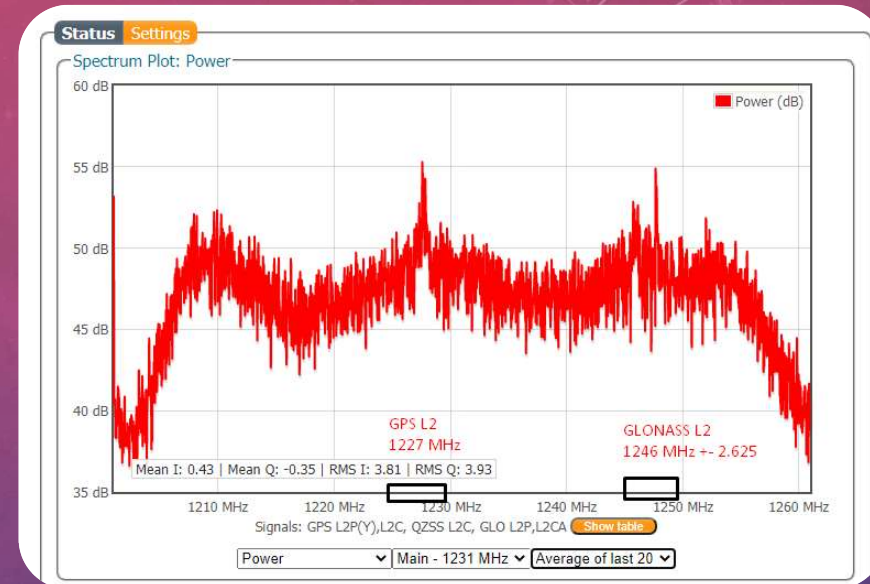
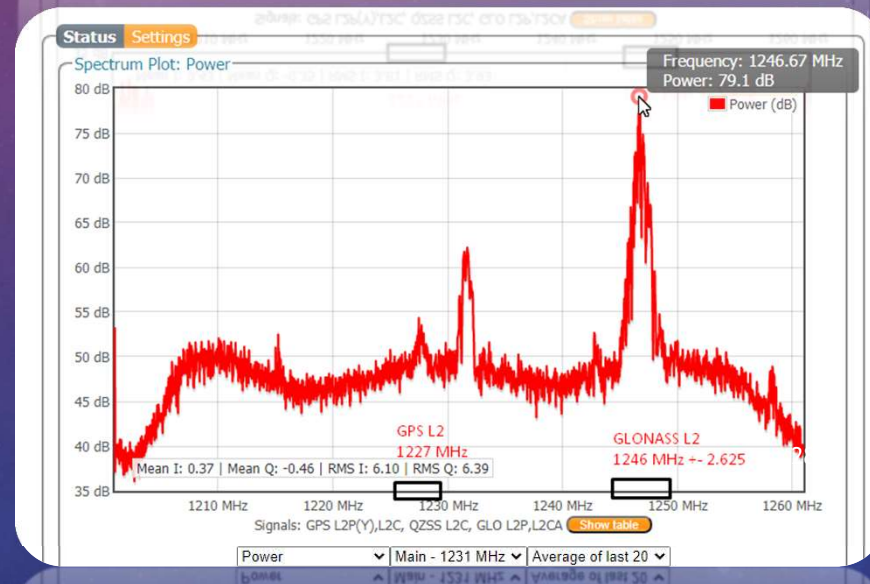
# SPECTRUM ANALYSES

Kanaal	GLO L1 MHz	GLO L2 MHz	PRN	Signaal	Freq. MHz
-7	1598.063	1242.938	10, 14	GPS L1	1575.42
-6	1598.625	1243.375		GPS L2	1227.60
-5	1599.188	1243.813		GPS L5	1176.45
-4	1599.750	1244.250	02, 06	GAL E1	1575.42
-3	1600.313	1244.688	18, 22	GAL E5a	1176.45
-2	1600.875	1245.125	09, 13	GAL E5b	1207.14
-1	1601.438	1245.563	12, 16	GAL E6	1278.75
0	1602.000	1246.000	11, 15	BDS B1	1561.10
1	1602.563	1246.438	01, 05	BDS B2	1207.14
2	1603.125	1246.875	20, 24	BDS B3	1268.52
3	1603.688	1247.313	01, 23		
4	1604.250	1247.750	17, 21		
5	1604.813	1248.188	03, 07		
6	1605.375	1248.625	04, 08		
7	1605.938	1249.063

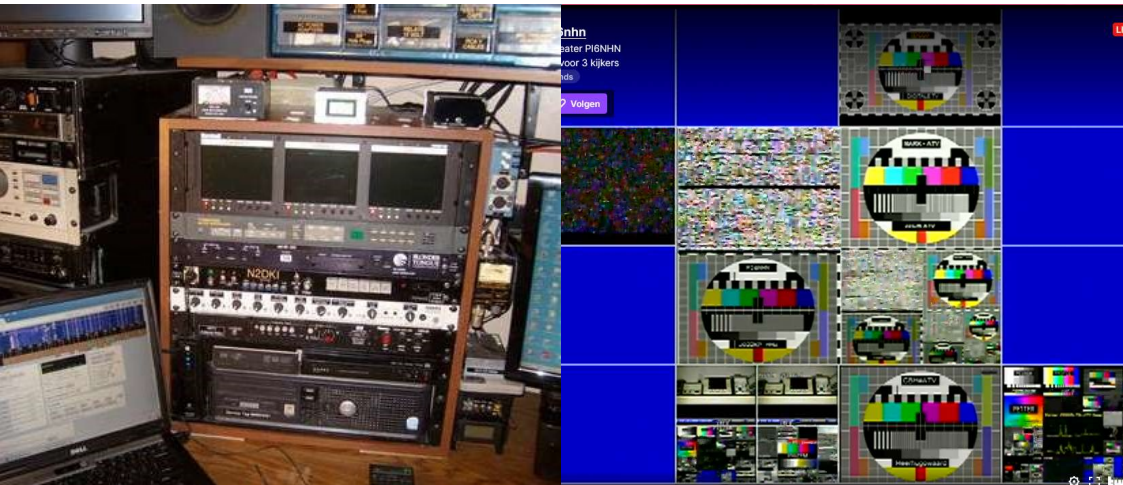
JOINING THEIR MEETING  
FOR INTERACTIVE  
SPECTRUM TESTING  
Share screen with  
members Radio  
amateur association.

Every user tests their  
frequency and signal  
strength

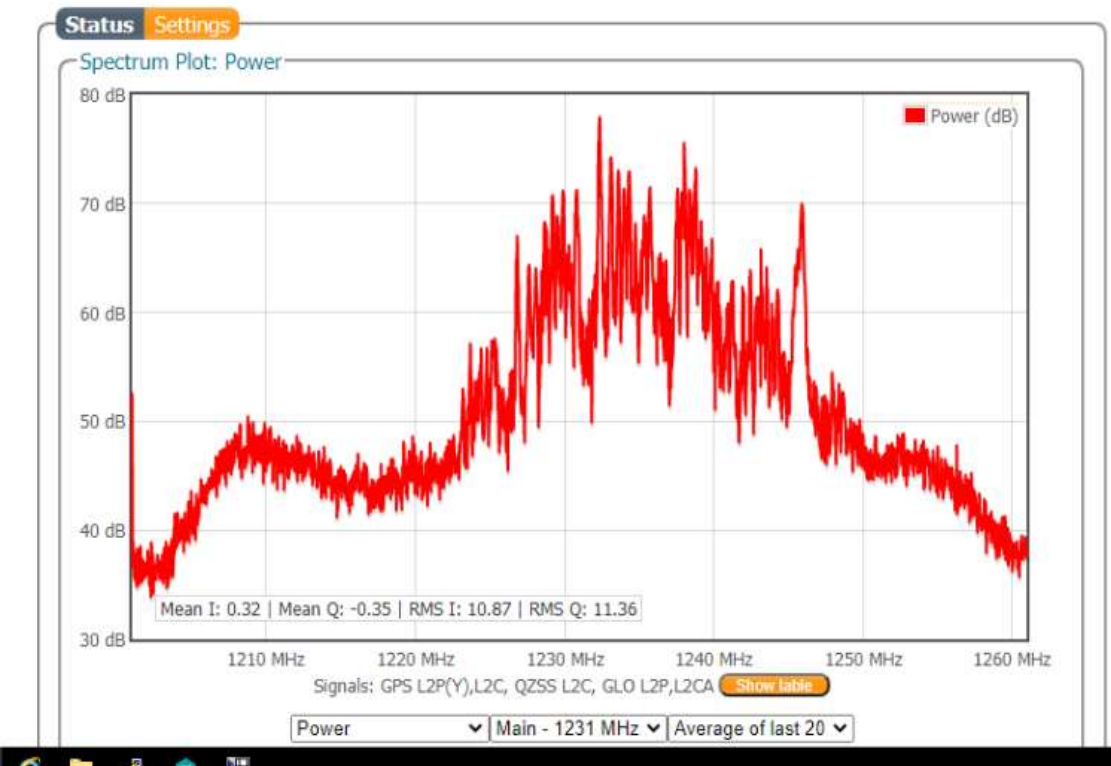
Life feedback, amount  
of interference shared

- During live feedback session the amateurs tested their broadcast limitation
  - 1 amateur used exactly GPS L2
  - 3 amateurs used GLONASS L2 to communicate
- Time-spectrum plot was shared afterwards
- Agreed to shift center frequency and lower power

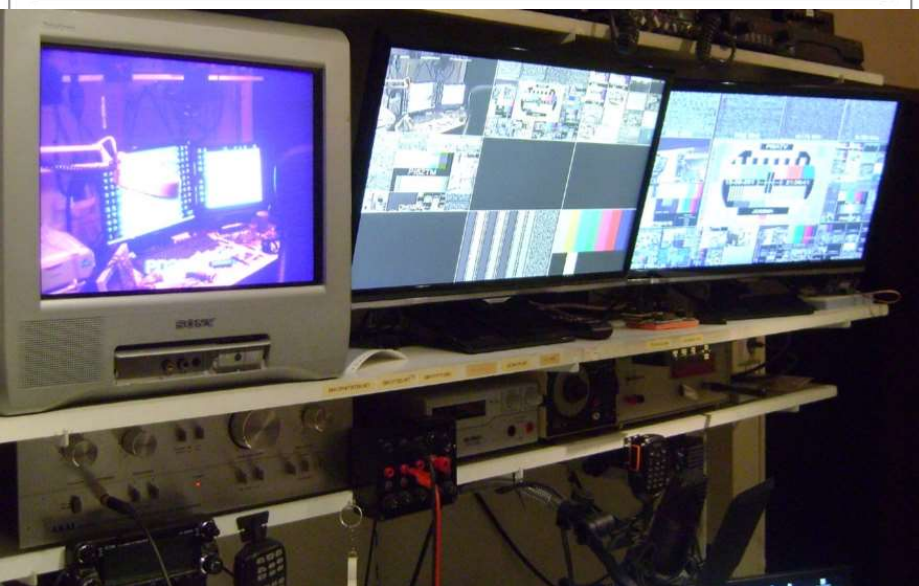
Monitoring performance GNSS-station with RINEX logs and network-performance

Radio Amateurs all moved to 1258 MHz
